Electrical Equipment Thermographic Survey Report

M/V NO SUCH VESSEL

ACME Shipping

01/01/2001

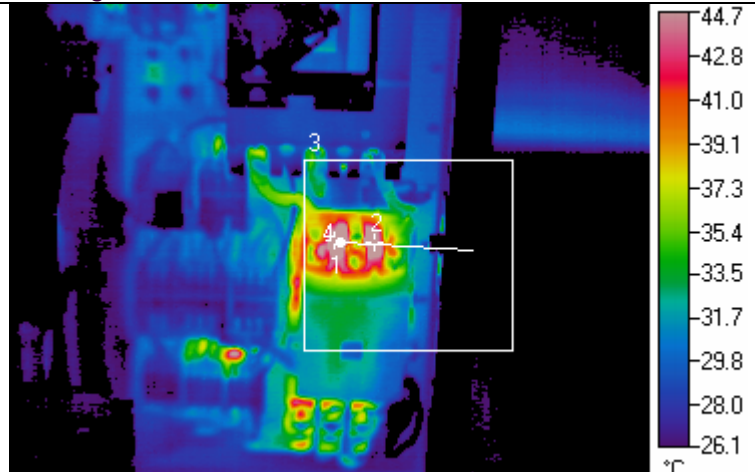
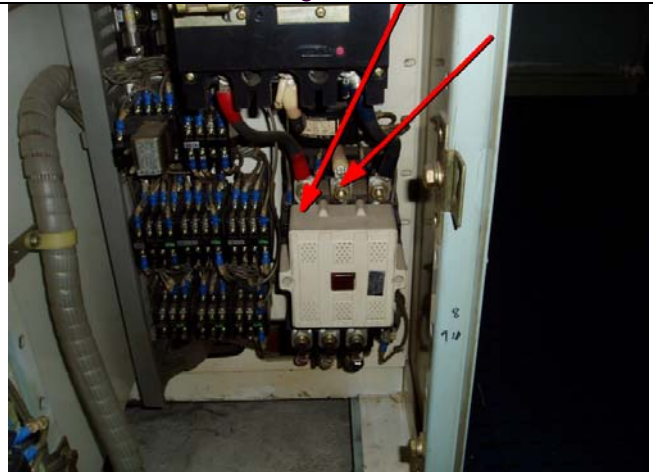
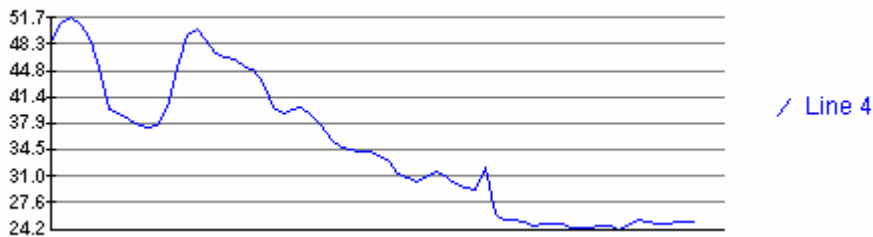
IR Image : TH710005.SIT 01/01/2001	Identification Image :

Priority Level	Medium
Equipment ID	No1 Main SW P/P low flow starter
Equipment Location	No 1 Motor Control Centre
Load	45 amps

Point1	Point2	Rect3	Line4
Emiss.	1.0	1.0	1.0	1.0
Avg			30.7 °C	34.7 °C
Min			24.1 °C	24.2 °C
Max	47.0 °C	46.6 °C	52.1 °C	51.7 °C
Delta

The problem in this starter is; the centre and left top fixed contacts require inspection and probably need to be changed
