Engine Room Hot Surfaces Thermographic Survey Report

M/V NO SUCH VESSEL

ACCME Shipping

01/01/2001

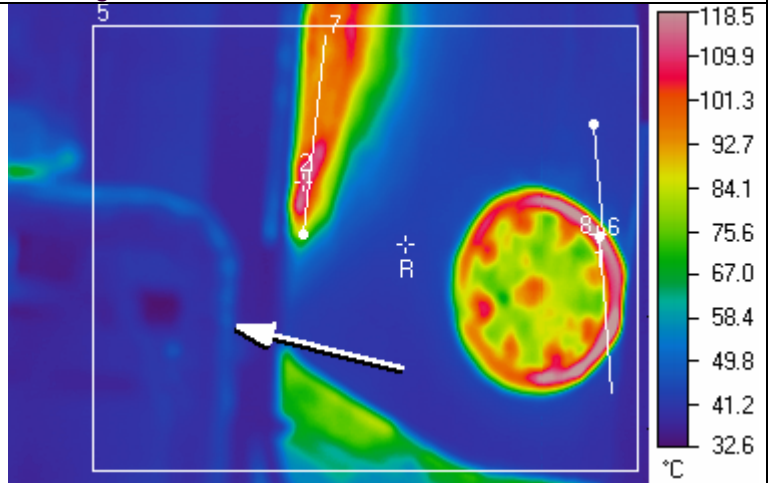
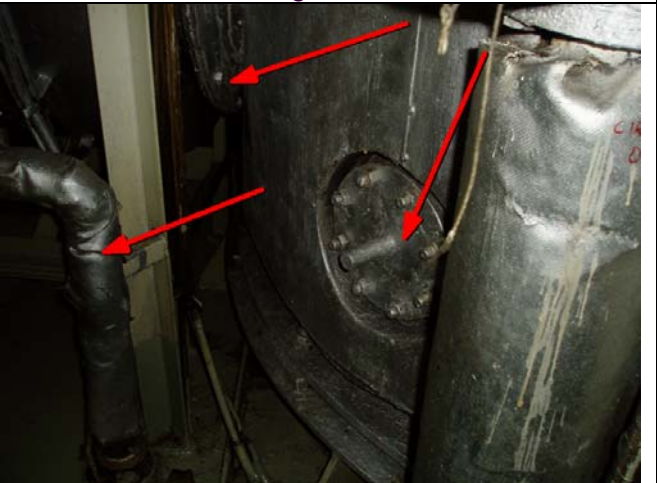
<p>IR Image : TH710003.SIT 01/01/2001</p>

Machinery ID	Auxiliary Boiler Scum Door and Boiler Insulation
Type	Sunrod
Machinery Location	Engine Room 2nd Level
Running Load / Condition	Half Load

Point1	Point2	Ref.	Rect5	Line6	Line7	Line8
Emiss.	1.0	1.0	1.0	1.0	1.0	1.0	1.0
Avg				51.8 °C	50.9 °C	99.1 °C	85.3 °C
Min				32.8 °C	41.5 °C	82.6 °C	41.0 °C
Max	121.1 °C	111.9 °C	42.5 °C	126.6 °C	119.9 °C	116.4 °C	123.8 °C
Delta	78.6 °C	69.4 °C		84.1 °C	77.4 °C	73.9 °C	81.3 °C

This door requires to be lagged and the insulation indicated by arrow needs repairing, as can be seen the arrow on left indicates the fuel line which if it leaks on to hot surface could cause a problem
