# Propulsion Machinery Thermographic Inspection

M/V NO SUCH VESSEL

**ACME Shipping**

01/01/2001

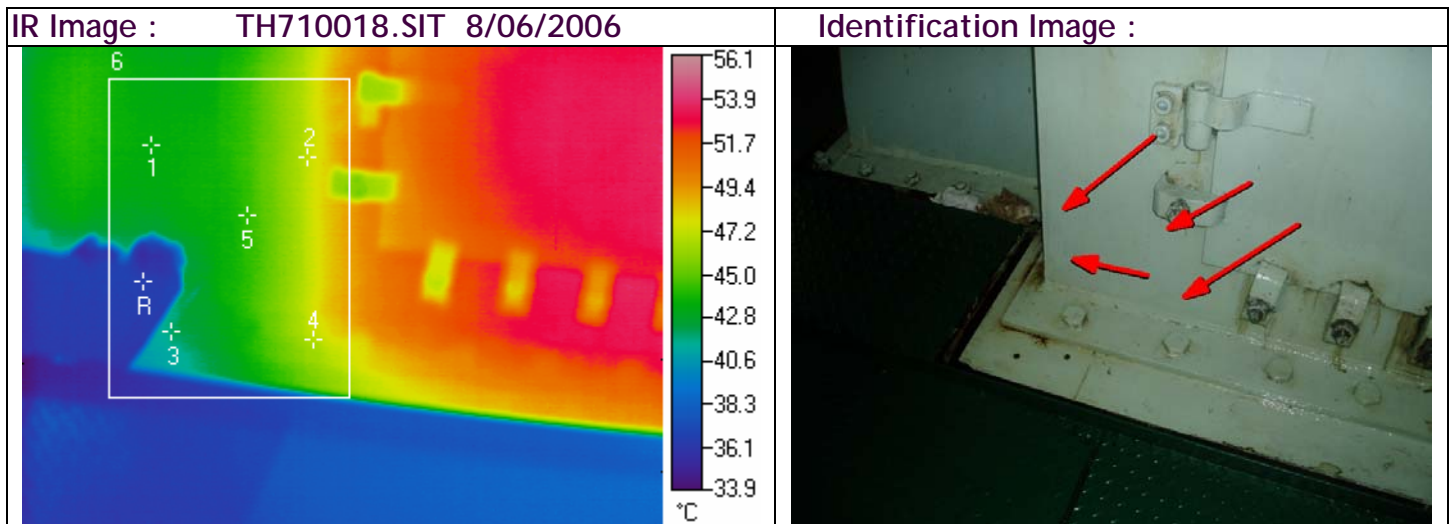
Machinery ID	M/E Bearing No 1
Type	Sulzer 7 RTA 72 U
Machinery Location	Main Engine
Running Load / Condition	Full Sea

Point1	Point2	Point3	Point4	Point5	Rect6	Ref.
Emiss.	1.0	1.0	1.0	1.0	1.0	1.0	1.0
Avg						43.5 °C	
Min						35.3 °C	
Max	43.4 °C	47.0 °C	41.8 °C	46.7 °C	44.2 °C	49.5 °C	36.6 °C
Delta	6.8 °C	10.4 °C	5.2 °C	10.1 °C	7.6 °C	12.9 °C

For Ship's Records
