Selected Machinery Thermographic Inspection

M/V NO SUCH VESSEL

ACME Shipping

01/01/2001

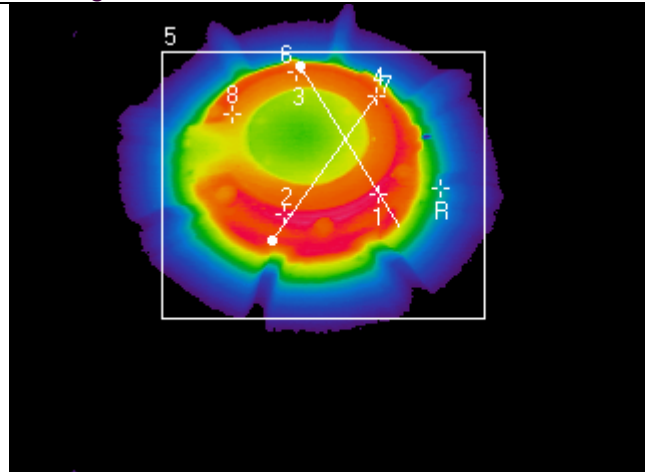
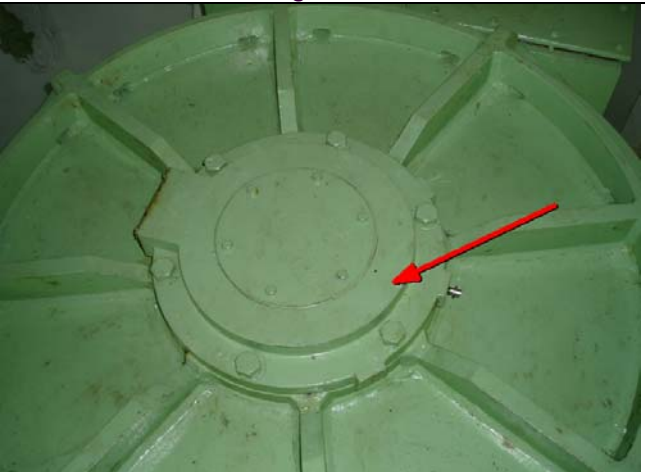
IR Image : TH710014.SIT 01/01/2001	Identification Image :

Machinery ID	Bow Thrust Motor Top Bearing
Type	
Machinery Location	Bow thrust Room
Running Load / Condition	Full

Point1	Point2	Point3	Point4	Rect5	Line6	Line7	Point8	Ref.
Emiss.	1.0	1.0	1.0	1.0	1.0	1.0	1.0	1.0	1.0
Avg					39.5 °C	46.2 °C	46.2 °C		
Min					26.8 °C	42.8 °C	42.9 °C		
Max	50.2 °C	50.3 °C	48.0 °C	48.3 °C	51.0 °C	50.6 °C	50.5 °C	46.7 °C	37.2 °C
Delta	13.0 °C	13.1 °C	10.8 °C	11.1 °C	13.8 °C	13.4 °C	13.3 °C	9.5 °C

After 30 minutes you see a rise at point 1 but the interesting reading is the delta which gives an over all temp rise which is 13 degrees from point one to three which would indicate heat on one side i.e. at point one. I recommend bearing keeper plate is removed and bearing inspected for signs of deterioration
