Battery Analyses Report

M/V NO SUCH VESSEL

ACME Shipping

01/01/2001

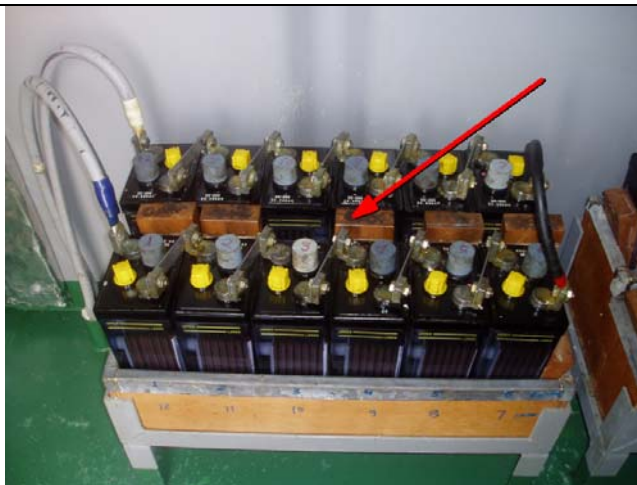
Identification Image :

Battery ID	EMERGENCY BATTERIES 200 AH
Battery Location	BATTERY ROOM AFT BRIDGE DECK
Battery Charge Level	5 AMPS
Battery Load Level	40 AMPS
Visible Condition	GOOD
Ambient Temperature	24
Measured Internal Resistance Value	13.4 m Ohm FOR EACH 12 VOLT SECTION

GOOD	GOOD	FAIR	GOOD	FAIL	GOOD
------	------	------	------	------	------

BATTERIES ARE IN GOOD CONDITION
